# Manhole Inspection Summary

Manhole # S59K\_\_020MH

Insp Date: **1/7/09 1:19 PM**

**Location** Address: **646 FOSTER AV**

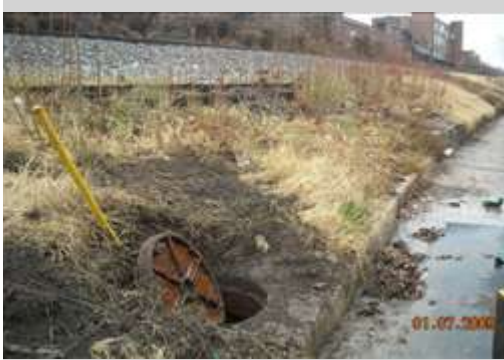
Location View

Comments **LOCATED WITH METAL DETECTOR, EXPOSED BURIED MANHOLE IN GRASS AREA, AND MANUALLY OPENED WITH 16LB MAUL.**
